**Subject: Response to EPA's January 19, 2017 Letter
Former Frenchtown Mill, Missoula County, Montana**

A – Photos Taken During Peak Clark Fork River Flows in 1997 Along Holding Pond 2 and at Outfall #3 Near Holding Pond 13A.

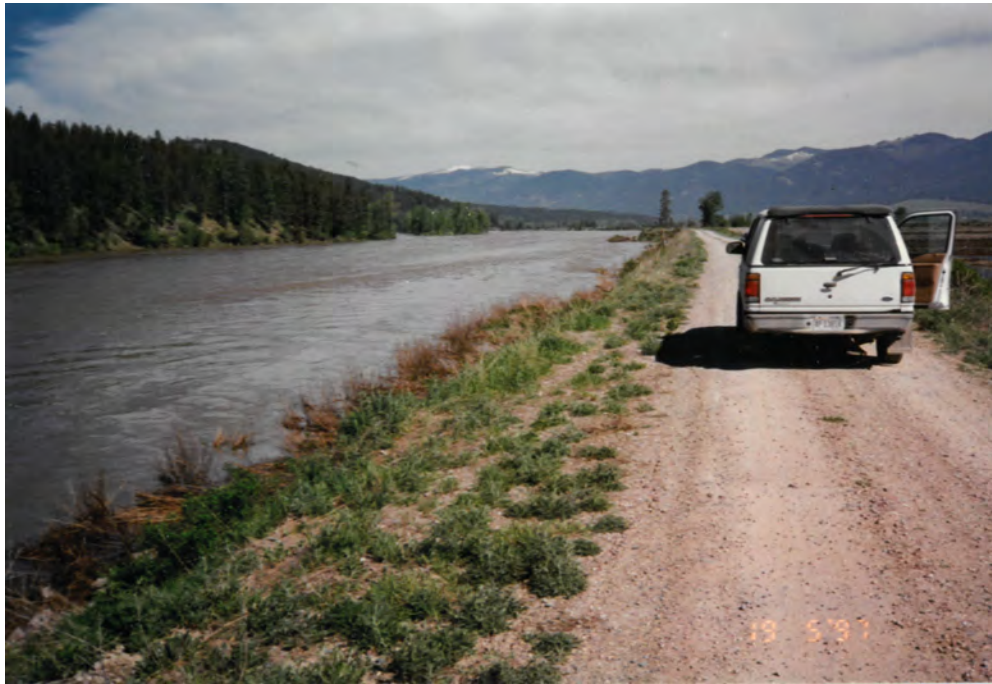
Photo 1:

Berm along Holding Pond 2, facing downriver (north). Clark Fork River during peak flow (approximately 54,000 cfs.)

The Clark Fork River (CFR) berm was constructed in segments between 1958 and 1970. Major flow events on the CFR between 1970 and the present are listed in **Table 1**. The highest CFR flows during this time period were recorded on May 18, 1997 at 55,100 cubic feet per second (cfs) at a gauging station below Missoula about 5 river miles upstream of the site. The May 1997 flow is considered a 30-year flood event by NewFields. The USGS and FEMA estimates of a 100-year flood event (61,700 and 64,000 cfs, respectively) are shown in **Table 2**. During the 1997 flow event, the CFR berm did not overtop or breach the berms and according to eye witnesses interviewed by NewFields, there was an estimated 6-8 feet of freeboard along the CFR berm from roughly Pond 2 to Pond 13A (**Attachment A**).

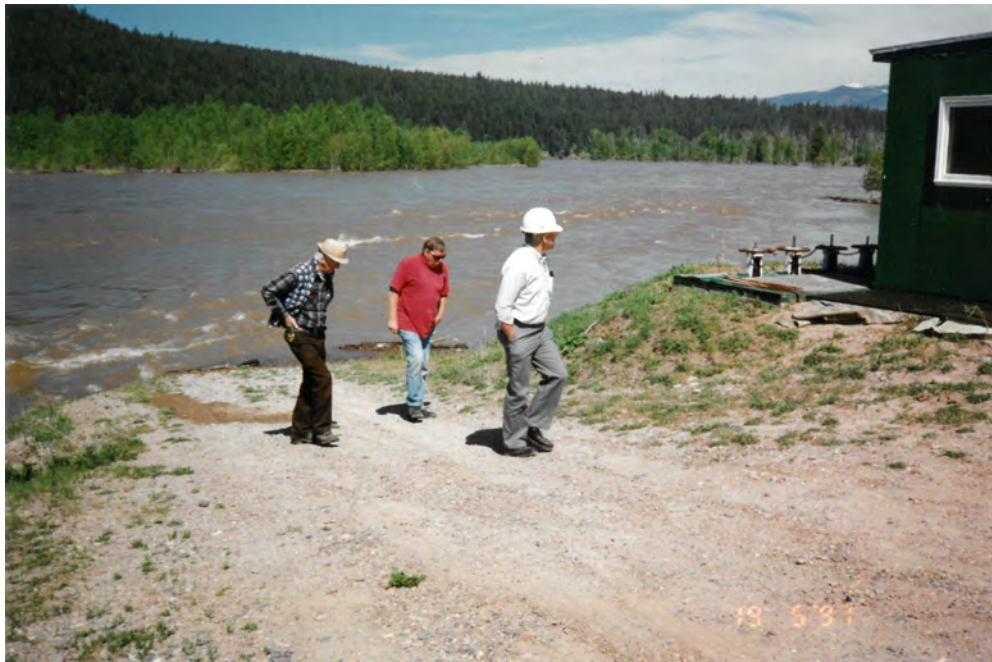
Photo 2:

Berm along Holding Pond 13A at Outfall #3, facing downriver (north). Clark Fork River during peak flow (approximately 54,000 cfs.)
